# Lake Gage and Lime Lake Engineering Feasibility Study

An Indiana Department of Natural Resources  
Division of Fish and Wildlife  
Lake and River Enhancement Project

December 16, 2005

Gensic Engineering Inc.

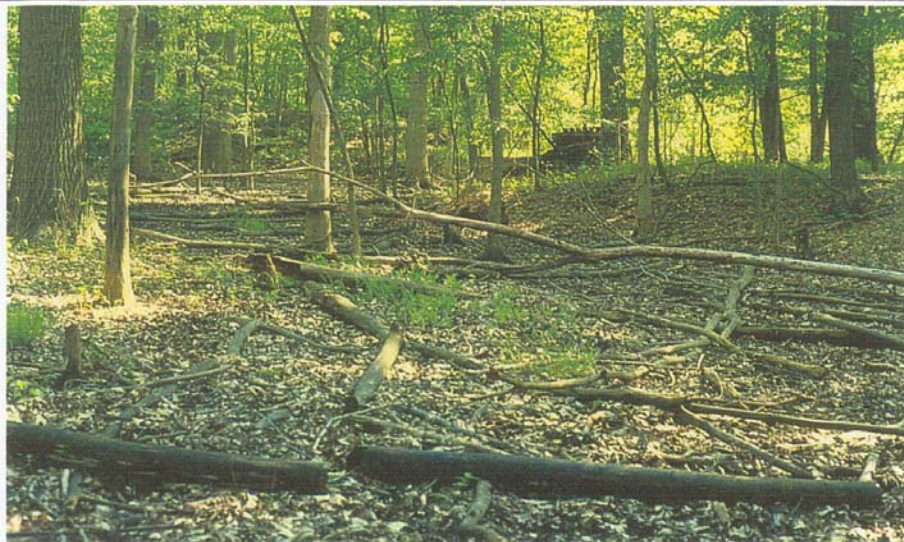
**Photo Point I:** View from interior of Wetland Section III; looking south west at former mill pond dam.

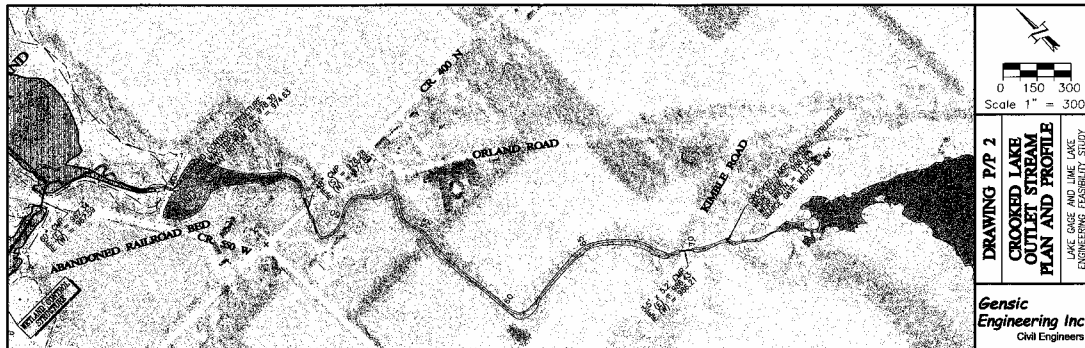
**DRAWING P/P 2**  
**CROOKED LAKE**  
**OUTLET STREAM**  
**PLAN AND PROFILE**  
 LAKE GAGE AND LIME LAKE  
 ENGINEERING FEASIBILITY STUDY
